## Engineer's Damaged Truss/Timber Evaluation

On 11/12/2025 a Damaged Truss Evaluation (DTE) was performed at the property located at address 123 Main St, Your City, Sample State, 12345, which consists of a 2600 square-foot single family no garage structure built in 2007 with a truss roof framing.

# Exhibit A - Damaged Area 1 (Damaged King Post)

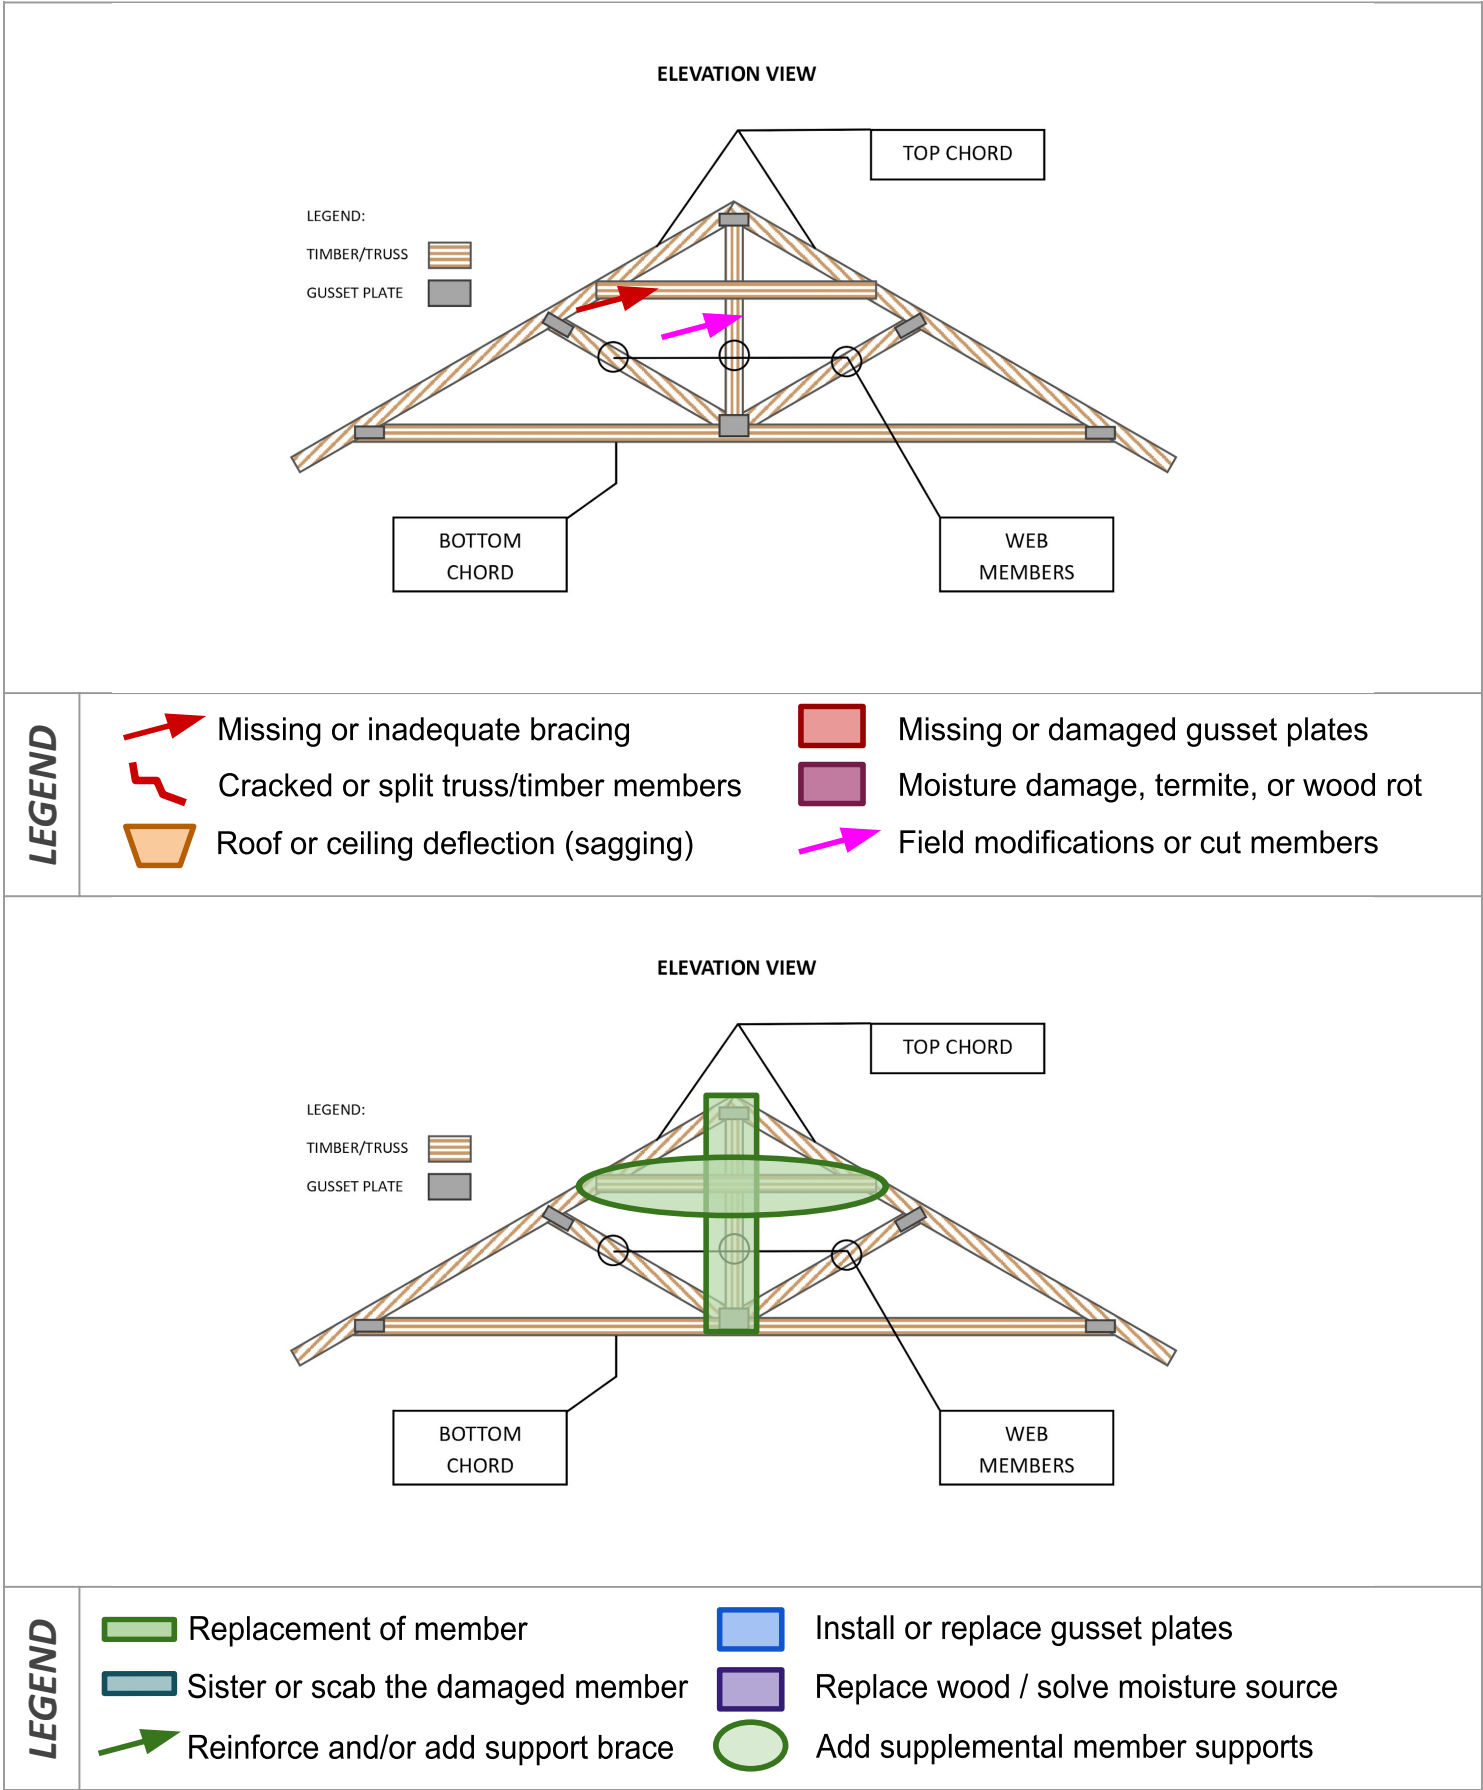
**Member Deflecting/Bowing:** We agree with the findings of the inspection report that the observed bowing of the king post of two truss members should be considered significant (See Exhibit A). The affected members exhibit noticeable bowing along their span, suggesting overstress, insufficient lateral restraint, or deformation due to sustained loading or moisture-related movement. The deflection indicates localized loss of stiffness and potential redistribution of loads within the truss system. While the overall roof structure remains generally intact, the bowed members may have a reduced capacity to maintain proper alignment and resist design loads.

**Replacement of Member:** For timber or truss member/s showing signs of deflection or bowing, remove the affected member/s and replace it with new dimensional lumber of the same grade and species, but constructed as a triple-laminated member (three 2× members fastened together) for increased capacity (see Exhibit B). Cut the replacement member/s to match the existing configuration and ensure tight bearing at connection points. Secure the new member/s using approved truss plates, gusset plates, or structural screws/bolts consistent with industry standards and truss repair guidelines. Verify that all connections are tight and properly aligned to maintain the original configuration and load path. Add collar ties as necessary, confirming proper connection to the king post, and fasten each collar tie using four (4) 10d common framing nails installed in a standard rectangular pattern, with two nails per row and two rows.
