# Executive Summary

# Engineer's Foundation Evaluation

On 3/26/2024 a foundation evaluation was performed at the property located at address 123 Main St, Your City, Your State, 12345, which consists of a 3079 square-foot single family attached structure built in 2008 (18 years old) with a slab on grade foundation.

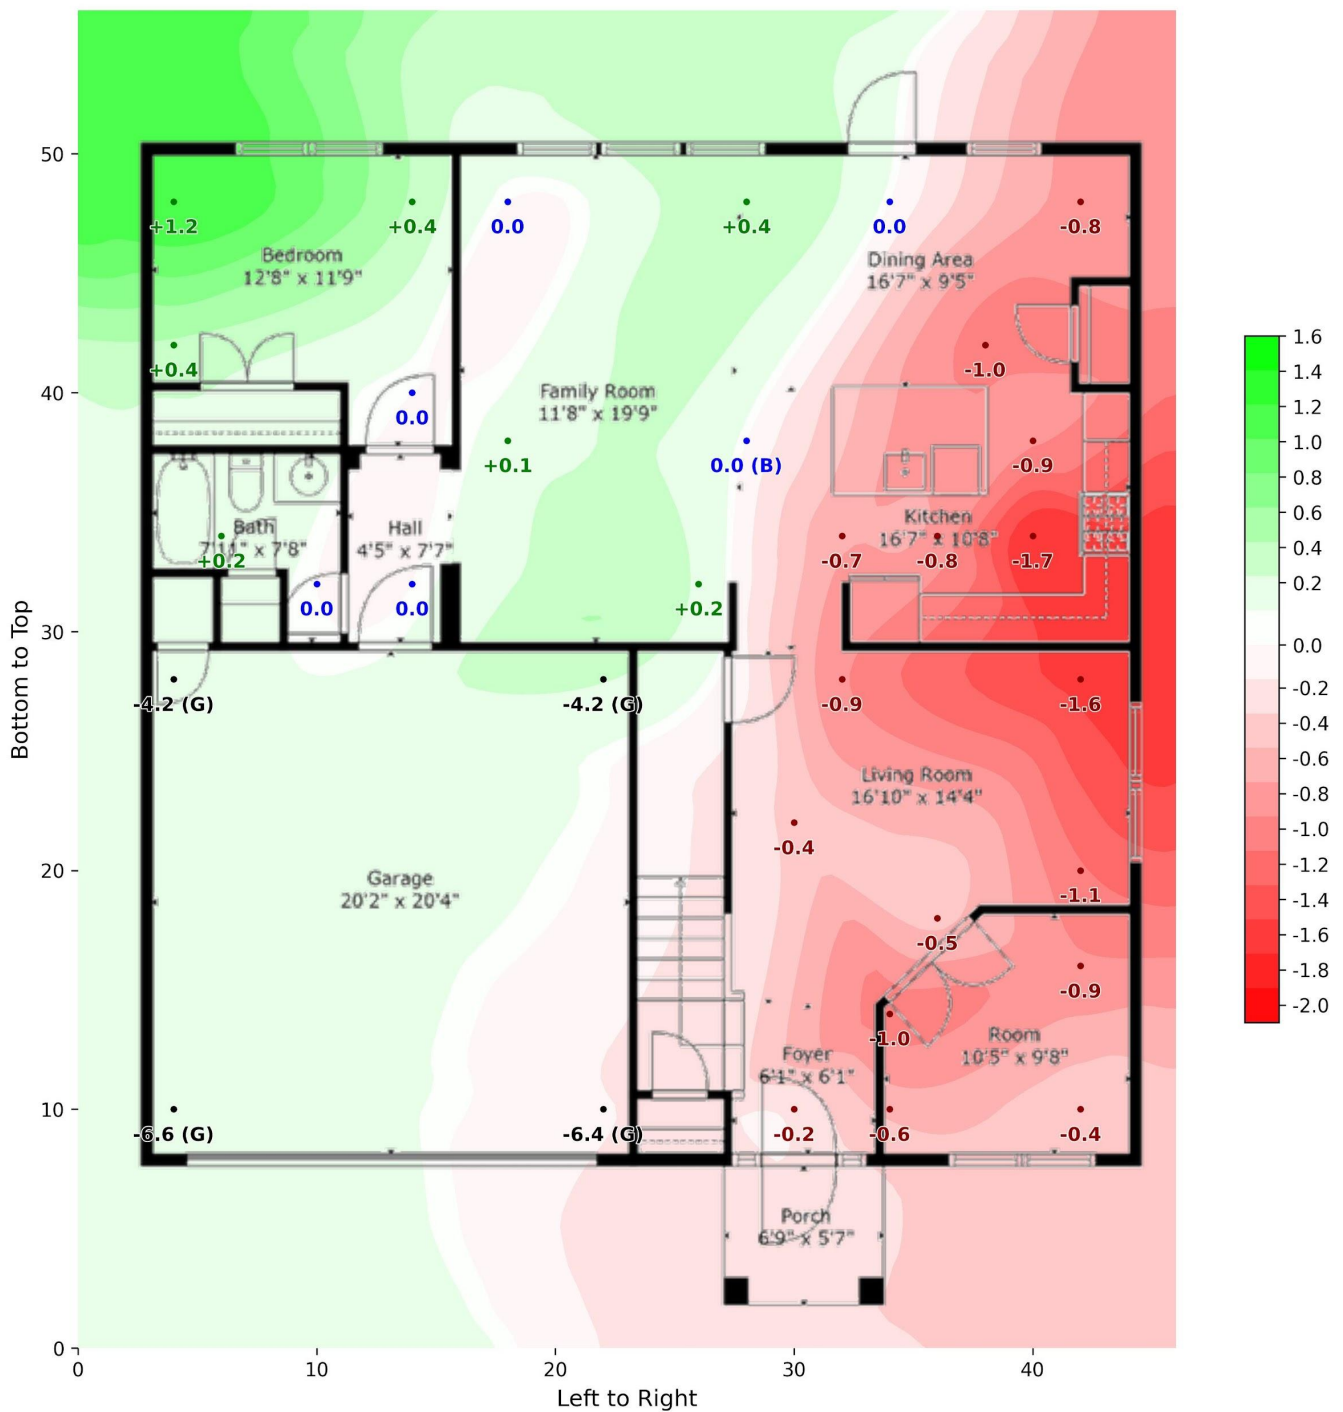
**Elevation Plot Graphic (Figure A)**

The elevation plot resulted in the graphic as depicted above in Figure A. The red-points and areas are elevation measurements that were lower than the base station elevation (0.0). The green-points and areas are elevation measurements that were higher than the base station elevation (0.0). The blue-points (and white areas) are equal to the base station elevation (0.0). The base station is depicted with a (B) symbol. The elevation plot takes into account differences in flooring thicknesses. The maximum elevation point was determined to be 1.2 inches and the minimum was -1.7 inches, resulting in an elevation difference of 2.9 inches of difference across the structure.

The elevation plot graphic above will show points labeled with a (G) symbol representing Garage. These elevation points were measured and plotted so they can be compared year-to-year, however, they are excluded from the foundation analysis. This is because garages can be non-monolithic and/or they are poured to purposefully slope toward the exterior garage door making any conclusions derived difficult to interpret.

Elevation differences across the structure are the first indicator that a foundation problem may or may-not exist. As documented above, the maximum elevation point of this structure was determined to be 1.2 inches and the minimum was -1.7 inches, resulting in an elevation difference of 2.9 inches of difference across the structure. The elevation plot takes into account differences in flooring thicknesses. The elevation deflection across an entire structure should, best-case-scenario, remain within 0.5 to 1-inch depending on the age of the structure. Measured differences approaching 2-inches are an initial sign of possible foundation fatigue. The maximum allowable elevation difference is subjective, depending on other factors such as the visual condition, size, and age of the structure (18 year(s) old) along with how the foundation performs when calculating deflection and tilt.

Based on observed elevations of the foundation from the elevation plot, the elevation differences do not fall within industry standards and tolerable limits. These findings indicate that the foundation does not have consistent and uniform elevation measurements. Note: elevation measurements alone are not the only indicator of foundation problems; see the deflection and tilt calculations (and the report's overall conclusion) for a complete understanding of foundation stabilization. If elevations fall outside of industry standard/tolerable limits, it is a first indicator that the foundation will fail in deflection and/or tilt.

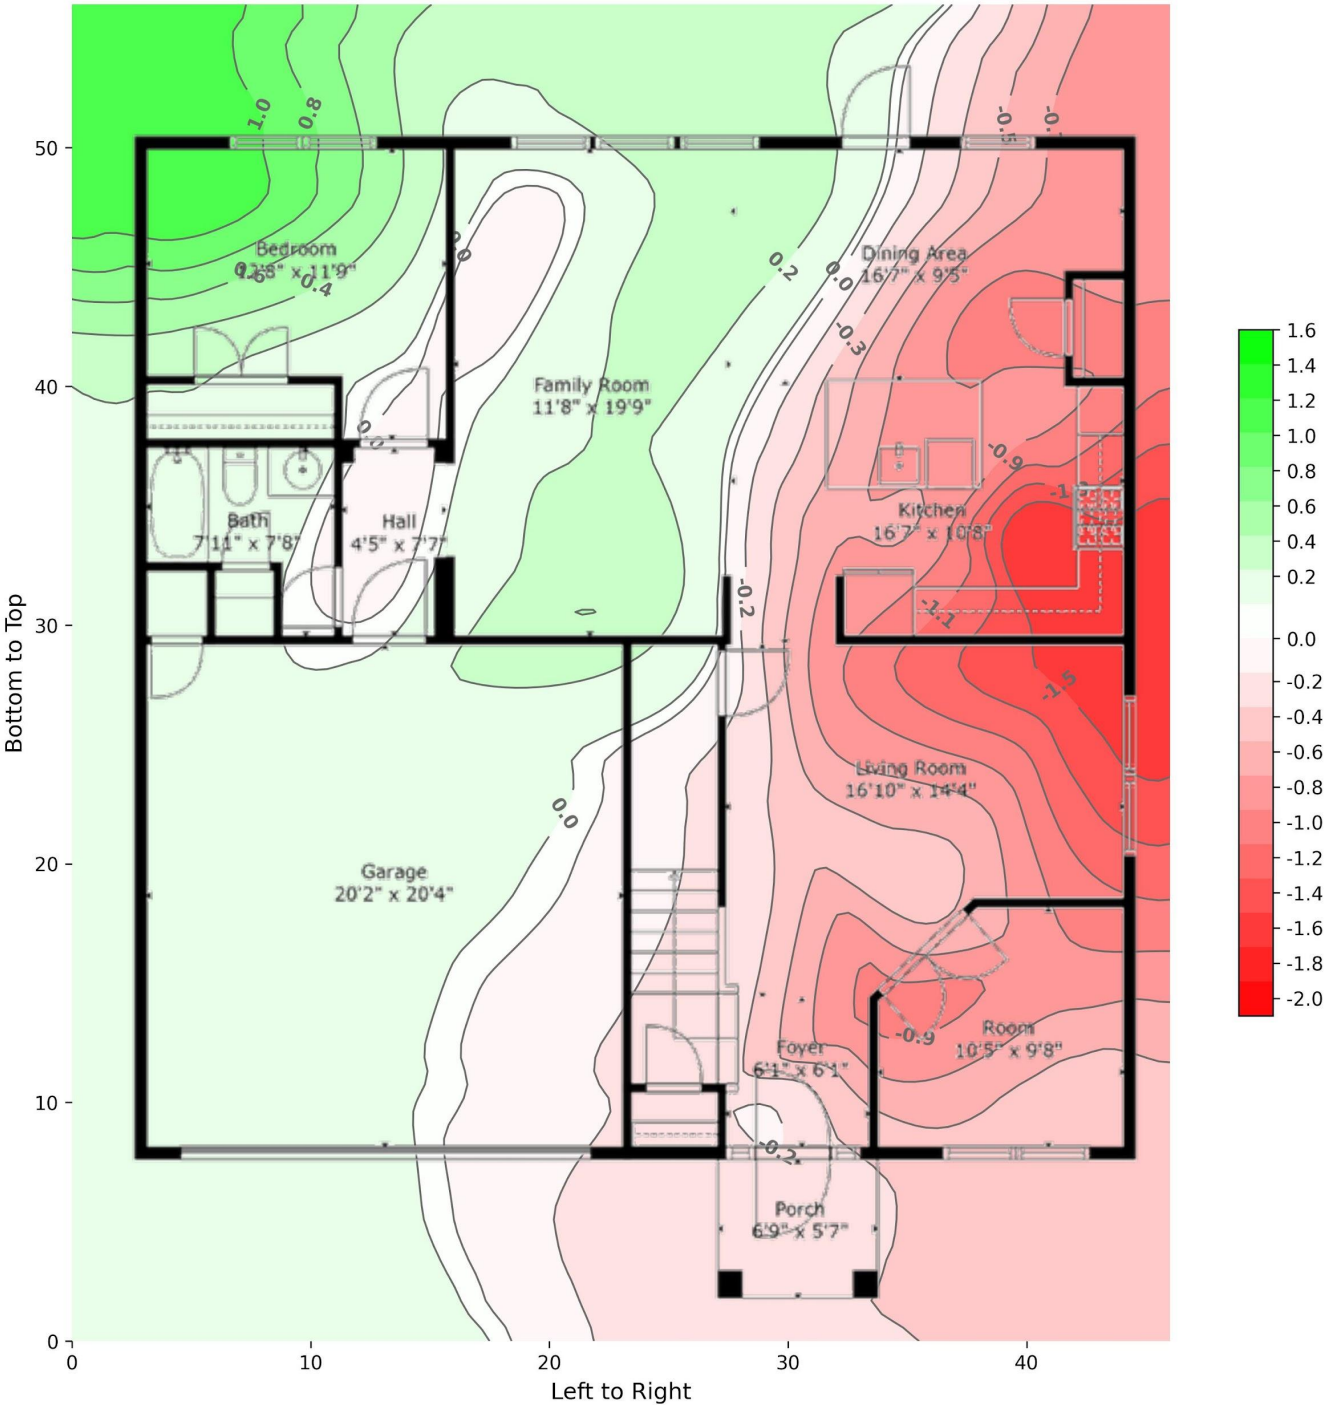
Mesh Contour Graphic (Figure B)

The mesh contours graphic depicted above in Figure B is similar to the elevation plot. The red, green, and white areas depict areas that are lower, higher, and equal to the base station elevation (0.0). The lines or contours (similar to map topography) are labeled at specific intervals.

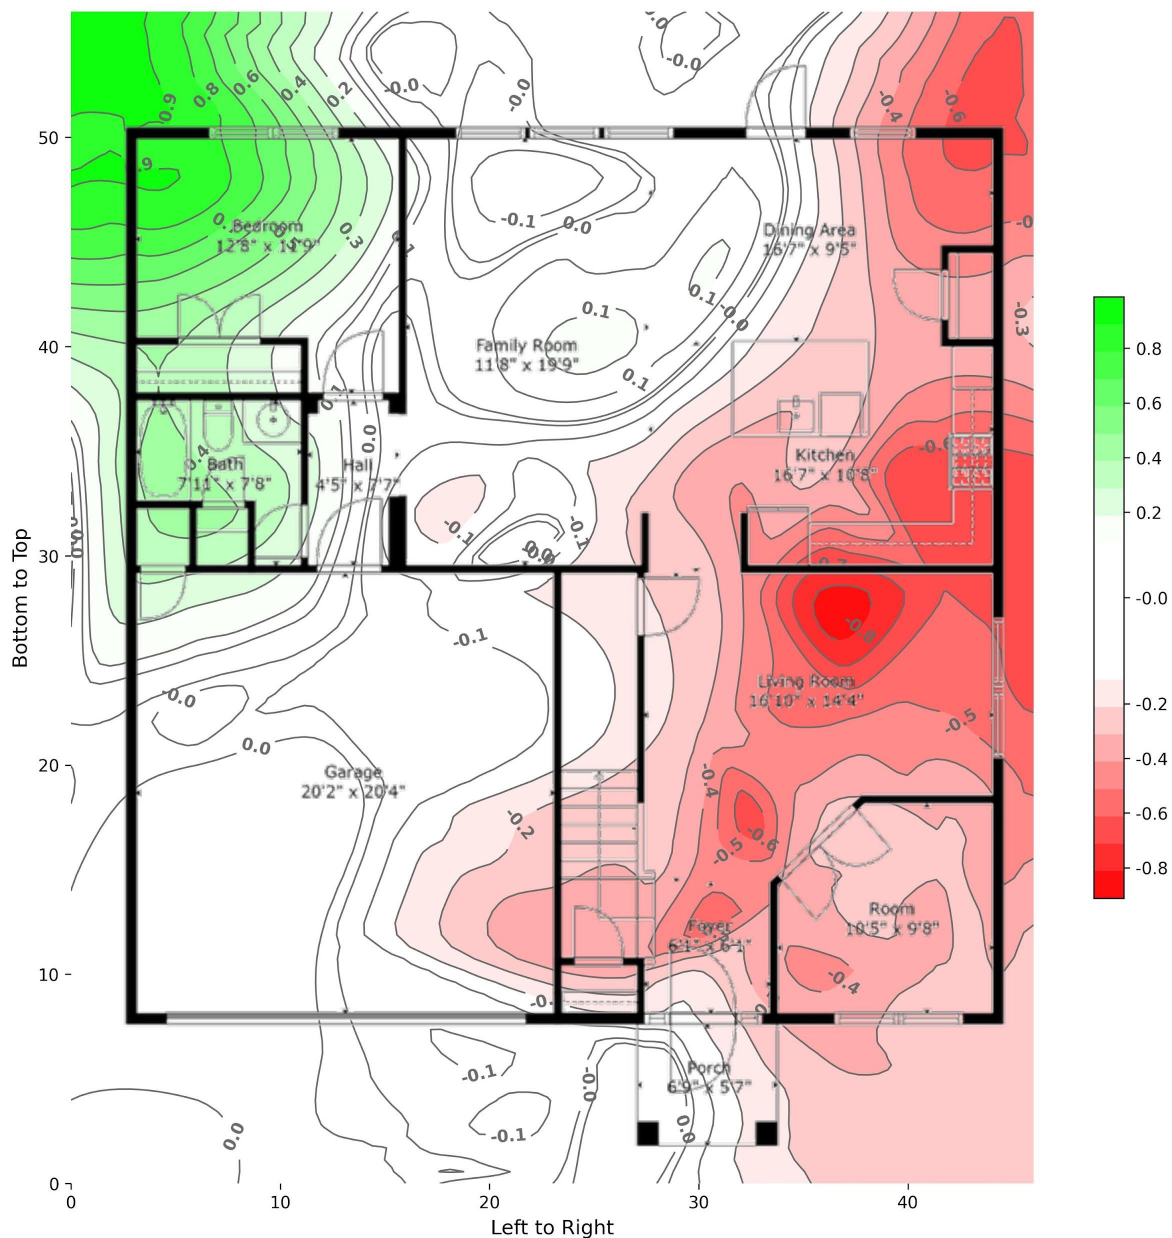
**Elevation Plot Difference Graphic (Figure F)**

A previous elevation plot completed in 2022 was available to use as a baseline of movement progression. Elevation differences are shown that show us the clear progression of movement from one date to another. As part of this evaluation, a contour mesh showing the elevation differences between the current contour mesh and the baseline was processed and is shown below.

The mesh contour graphic above in Figure F shows areas in red that are lower than the baseline elevation plot and areas of green that are higher than the baseline elevation plot (from the provided drawing completed in 2022). The darker the color (both red and green) the larger/smaller the elevation differences.
