## Engineer's Damaged Truss/Timber Evaluation

On 11/12/2025 a Damaged Truss Evaluation (DTE) was performed at the property located at address 123 Main St, Your City, Sample State, 12345, which consists of a 2600 square-foot single family no garage structure built in 2007 with a truss roof framing.

# Exhibit A - Damaged Area 1 (Damaged King Post)

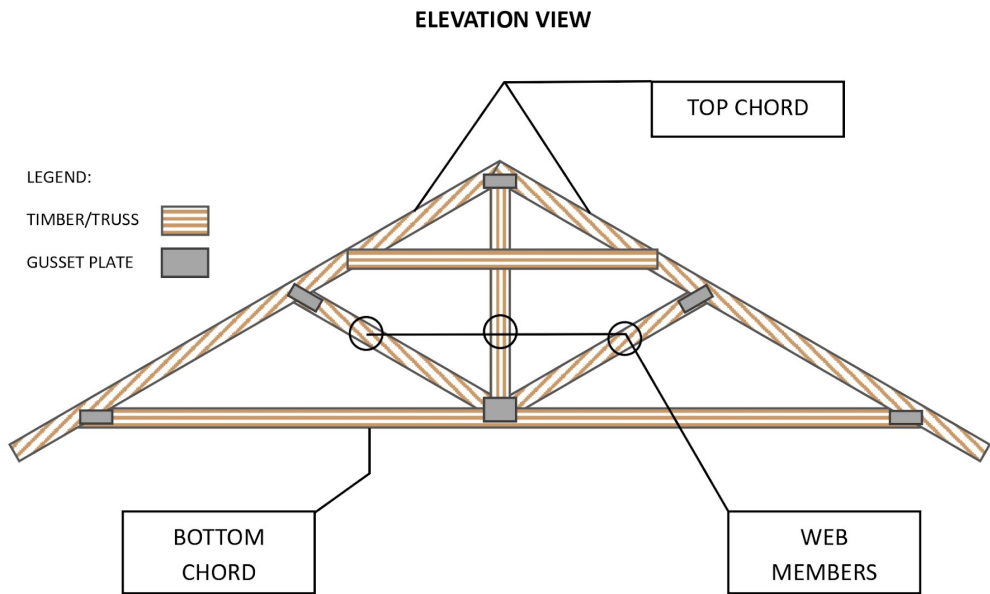
**Framing Type: FULL TRUSS**

**Member Deflecting/Bowing:** We agree with the findings of the inspection report that the observed bowing of the king post of two truss members should be considered significant (See Exhibit A). The affected members exhibit noticeable bowing along their span, suggesting overstress, insufficient lateral restraint, or deformation due to sustained loading or moisture-related movement. The deflection indicates localized loss of stiffness and potential redistribution of loads within the truss system. While the overall roof structure remains generally intact, the bowed members may have a reduced capacity to maintain proper alignment and resist design loads.

**Visual discovery of previous repair work:** We agree with the findings of the home inspection report that there exists signs of previous roof framing repair that were completed to the structure. Multiple scabs are observed throughout the truss/timber framing. Additionally, two A-frames placed end-to-end of the attic sitted with a thick joist is found that appears to provide additional support to the roofing system. A review of the attic framing indicates that the prior alterations and installations were completed with substandard workmanship and do not conform to typical industry quality standards. However, aside from the noted deficiencies at the identified king posts, the additional framing does not appear to be structurally compromising based on current conditions. No invasive or destructive structural investigation were performed to confirm the material properties of the lumber used.

**Replacement of Member:** For timber or truss member/s showing signs of deflection or bowing, remove the affected member/s and replace it with new dimensional lumber of the same grade and species, but constructed as a triple-laminated member (three 2× members fastened together) for increased capacity (see Exhibit B). Cut the replacement member/s to match the existing configuration and ensure tight bearing at connection points. Secure the new member/s using approved truss plates, gusset plates, or structural screws/bolts consistent with industry standards and truss repair guidelines. Verify that all connections are tight and properly aligned to maintain the original configuration and load path. Add collar ties as necessary, confirming proper connection to the king post, and fasten each collar tie using four (4) 10d common framing nails installed in a standard rectangular pattern, with two nails per row and two rows.
